SIB 12 30 19

RECALL 19V-XXX: TRANSMISSION WIRING HARNESS

PROCEDURE A - Reposition the transmission wiring harness

PROCEDURE B - Rework the transmission wiring harness

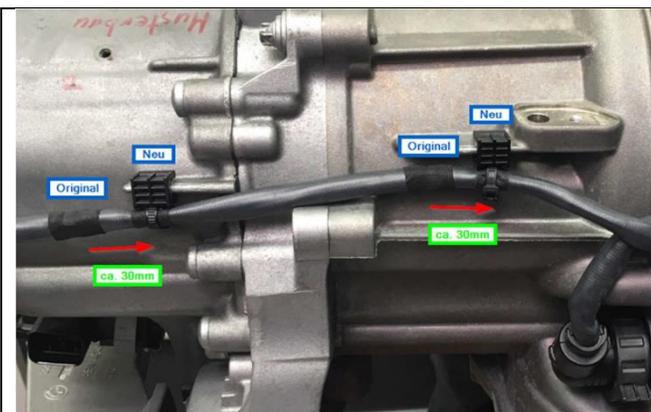
The cable strap location must be moved approximately 1 3/16 inches toward the front of the vehicle.

16. Secure the clips with the openings facing upwards (see graphic).

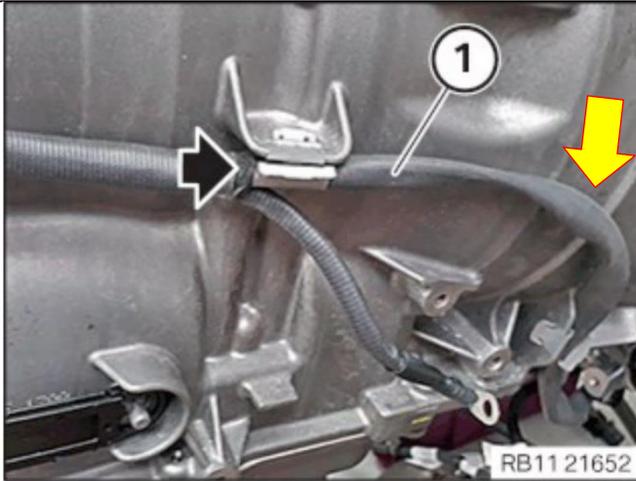
Note: Ensure enough slack so the harness is not pulled taught over the transmission housing casting lines.

20. Hook in transmission wiring harness 1 (see graphic).

21. Secure transmission grounding.

Ground connection on the transmission
Screw M6 x 12: Tightening torque 10 Nm.

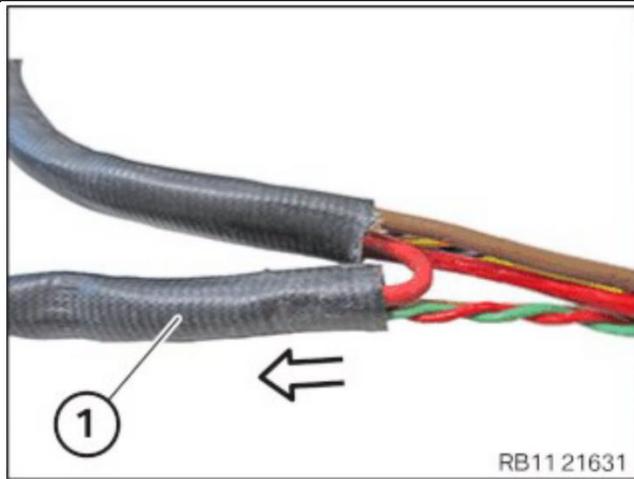
11. Check cable for damage.

Important: Steps 12 thru 20 must be performed even if damage is not observed.

10. Push insulating sleeve (1) back in direction of the arrow 110 mm (approximately 4 ½ inches).

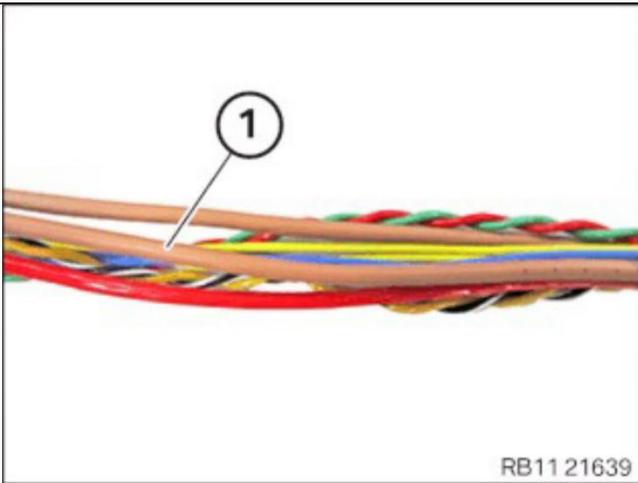
21. Check grounding cables (1) for damage and, if necessary, repair with an insulating sleeve.

Note: Do not perform steps 22 thru 27 if damage is not observed.

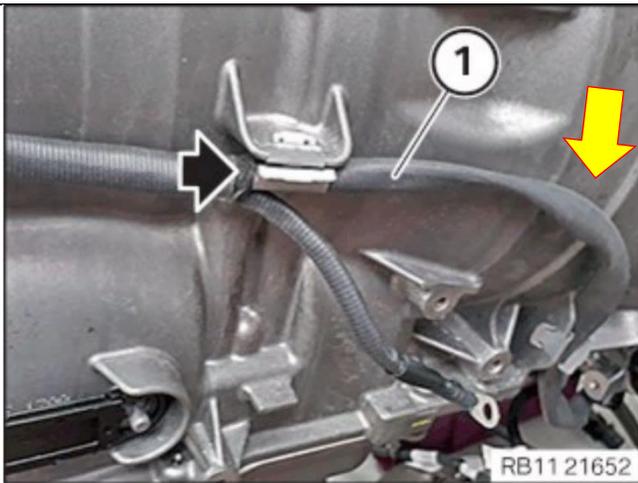
Note: Ensure enough slack so the harness is not pulled taught over the transmission housing casting lines.

40. Hook in transmission wiring harness (1).

41. Secure transmission ground lug.

Ground connection on the transmission
Screw M6 x 12: Tightening torque 10 Nm.
